IN STORE SERVICE

SERVICING THE TIME COMPUTER/CALCULATOR

SERVICING TOUCH/COMMAND MODELS (CONT.)

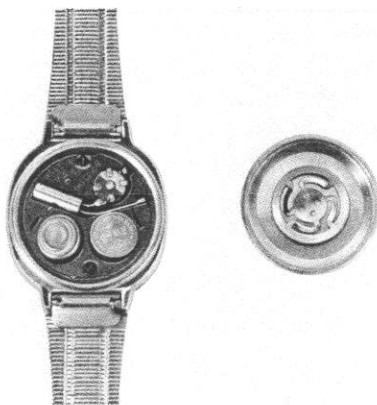
Touch/Command models have a standard screw-back case construction. To remove the case back, use the proper tool provided by Pulsar. Note that, when the case back is removed, the module rises slightly out of the case.

Note which cell is "plus side up" and "plus side down." Instructions are printed in each cell compartment but may be partially obscured by the cell leads.

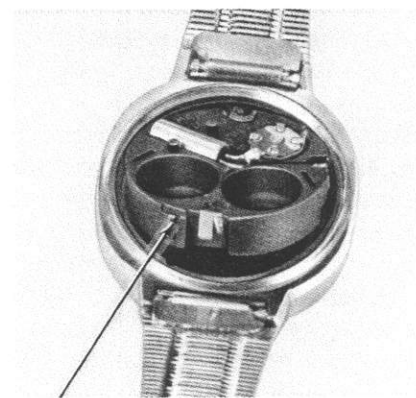
There are no screws to hold the module in the case. When the case back is removed, the module can be lifted out with a pair of tweezers.

Note that the module has a small T-shaped protrusion on its outer edge, just to the left of the contact spring at "6 o'clock" position. When replacing the module in the case, align this protrusion with the small groove in the comparable position on the inside of the case back. When you replace and tighten the case back, the module is properly seated in operating position.

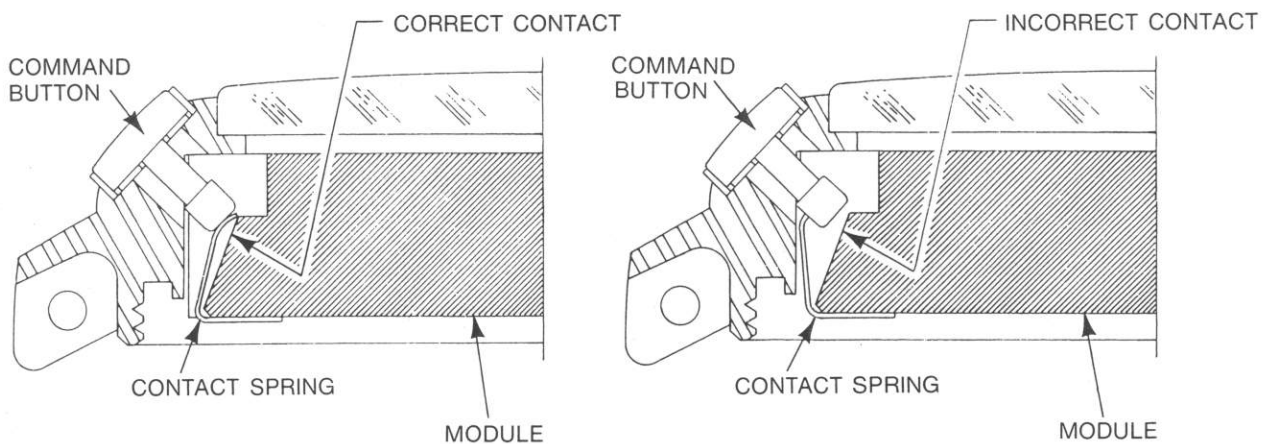
When replacing the module in the case, be sure to keep it flat and straight, to insure proper contact spring position. The contact springs (at 6 and 12 o'clock positions on the module edge) must be kept **inside** the button posts, as shown below.
